**A CHARACTERIZATION AND ANALYSIS
OF THE FLOOR PLASTERS
FROM THE ACROPOLIS AT COPAN, HONDURAS**

A THESIS

**The Graduate Program in Historic Preservation in
Partial Fulfillment of the Requirements for the Degree of the Master of Science**

1998

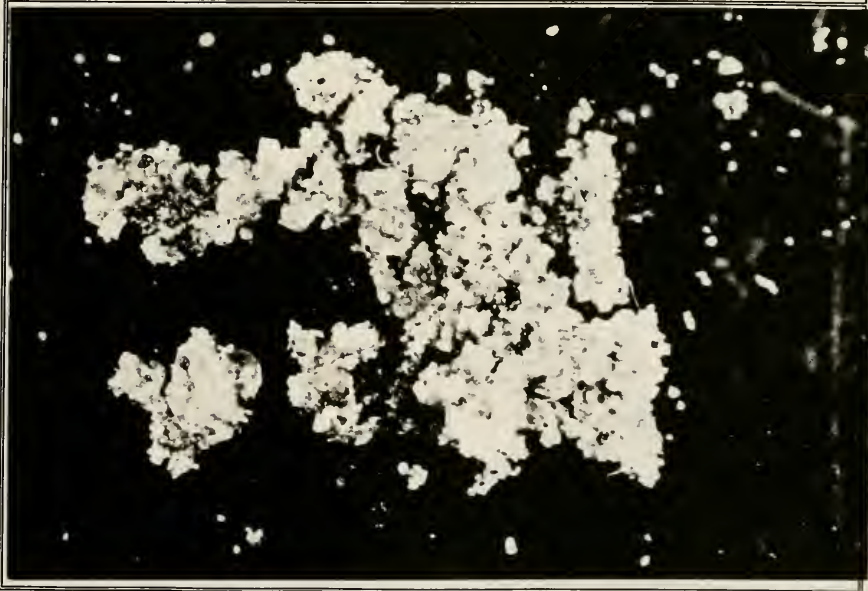
COARSE FRACTION EXAMINATION		SAMPLE #: 81	
Floor Name: Chaj			
Sample Location: MAS, abuts Ceiba on north side, under Acatan			
Division: 5, MAS 7		Date: A.D. 460 - 470	Magnification: 7.5x
Shapes: Round, subround and subangular.			
Colors: Gray, brown, green, tan with rust, white, and red.			
SIEVE ANALYSIS			
Sieve #	Size	Weight (grams)	% Retained
8	2.36 mm	0.8	70.17
16	1.18 mm	0.1	8.77
30	600 μm	0.08	7.02
50	300 μm	0.04	3.5
100	150 μm	0.06	5.26
200	75 μm	0.06	5.26
Pan		0	0

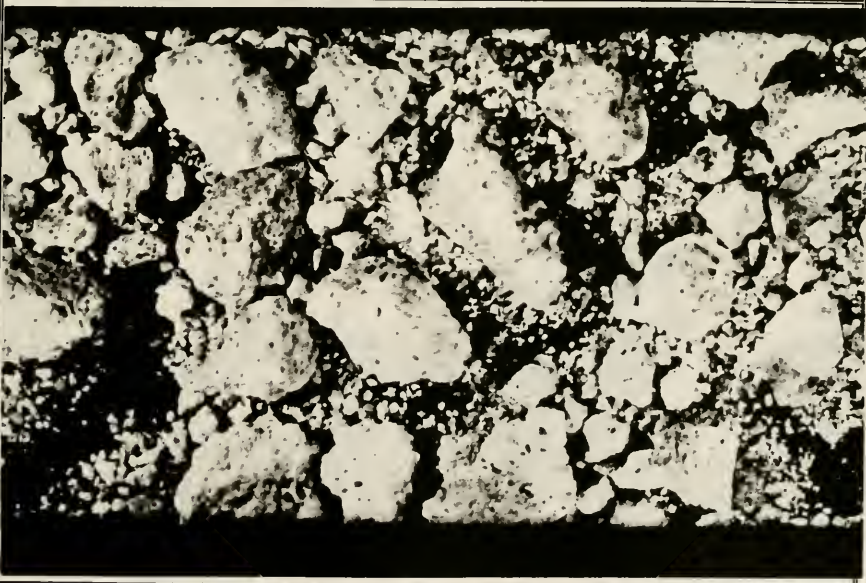
A black and white photomicrograph showing a dense collection of coarse fraction particles. The particles are subround to subangular, with varying sizes and shapes. Some particles are light-colored (white or light gray) and others are darker (gray or black). The overall texture is granular and heterogeneous.

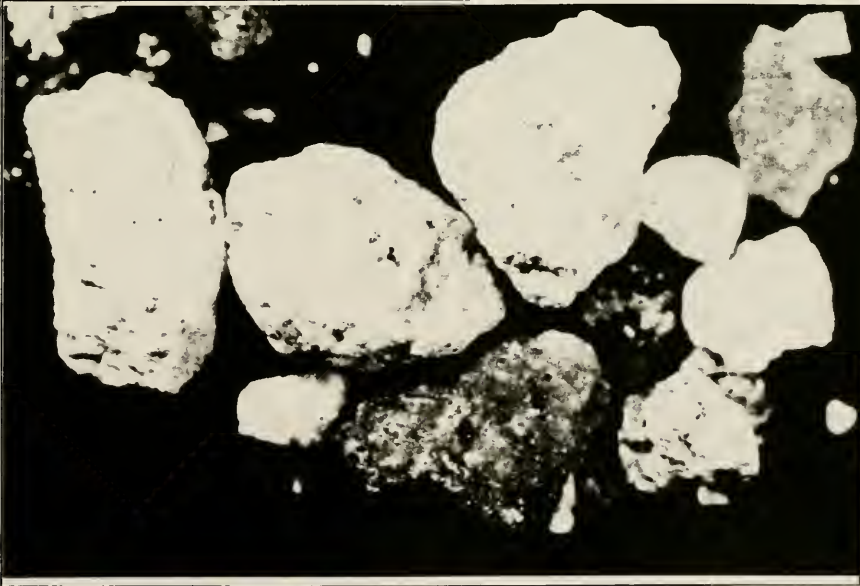
COARSE FRACTION EXAMINATION		SAMPLE #: 88	
Floor Name: Bringuez			
Sample Location: MAS, west of Tuna. Central area of west side.			
Division: 5, MAS 7		Date: A.D. 460 - 470	Magnification: 7.5x
Shapes: Round, subround, angular, and subangular.			
Colors: Brown, gray, tan, green, white, and reddish-brown.			
SIEVE ANALYSIS			
Sieve #	Size	Weight (grams)	% Retained
8	2.36 mm	0	0
16	1.18 mm	0	0
30	600 μm	0.08	13.79
50	300 μm	0.16	27.59
100	150 μm	0.14	24.14
200	75 μm	0.14	24.14
Pan		0.06	10.34

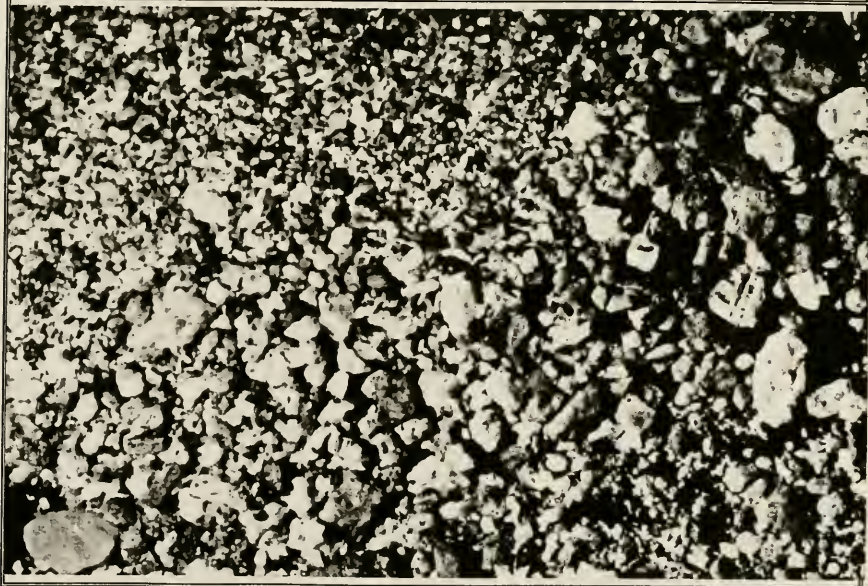
COARSE FRACTION EXAMINATION		SAMPLE #: 89	
Floor Name: Reina			
Sample Location: MAS, west of central area of Tuna, west side.			
Division: 5, MAS 7		Date: A.D. 460 - 470	Magnification: 5x
Shapes: Subangular and subround.			
Colors: Green, gray-brown, tan, rust, gray and translucent white.			
SIEVE ANALYSIS			
Sieve #	Size	Weight (grams)	% Retained
8	2.36 mm	0.36	26.86
16	1.18 mm	0.44	32.83
30	600 μm	0.12	8.95
50	300 μm	0.2	14.92
100	150 μm	0.18	13.43
200	75 μm	0	0
Pan		0.4	2.98

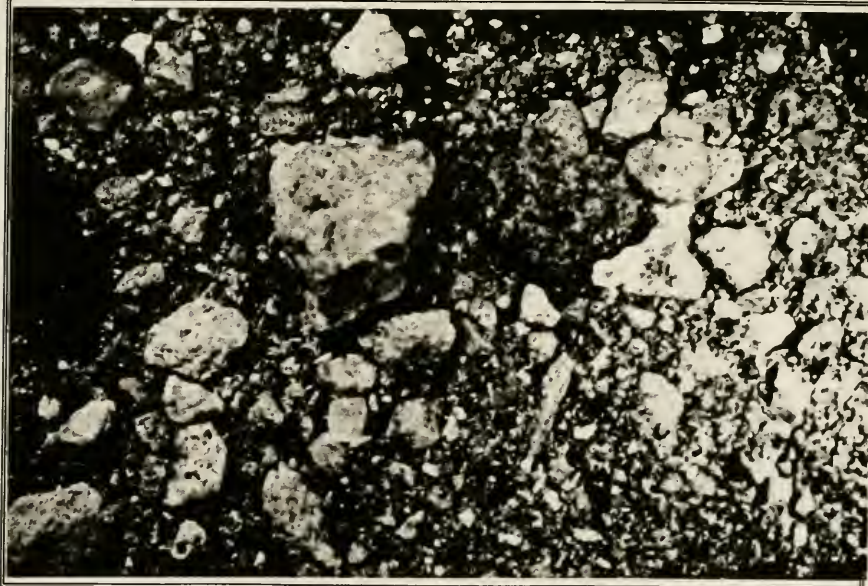
COARSE FRACTION EXAMINATION		SAMPLE #: 90	
Floor Name: Banano			
Sample Location: MAS, west of central area of Tuna, below Reina.			
Division: 5, MAS 7	Date: A.D. 460 - 470	Magnification: 6.25x	
Shapes: Subround and subangular.			
Colors: Tan, white, brown, green, gray, and rust.			
SIEVE ANALYSIS			
Sieve #	Size	Weight (grams)	% Retained
8	2.36 mm	0	0
16	1.18 mm	0.1	35.72
30	600 μ m	0.14	50
50	300 μ m	0	0
100	150 μ m	0.04	14.28
200	75 μ m	0	0
Pan		0	0

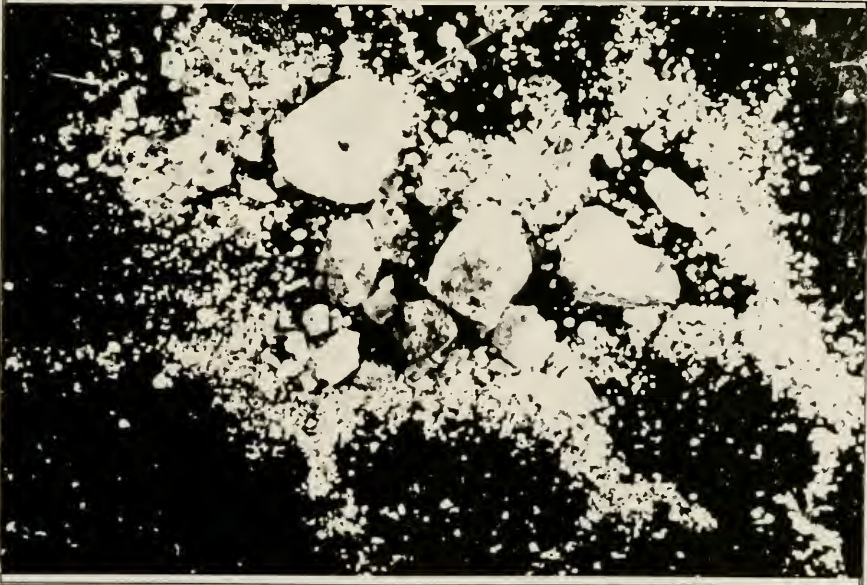
COARSE FRACTION EXAMINATION		SAMPLE #: 95	
Floor Name: Asmen			
Sample Location: MAS, west of Margarita, below Asmen.			
Division: 5, MAS 9	Date: A.D. 440 – 450	Magnification: 6.25x	
Shapes: Subround and subangular.			
Colors: Green, yellow, gray, white, rust, and translucent.			
SIEVE ANALYSIS			
Sieve #	Size	Weight (grams)	% Retained
8	2.36 mm	0	0
16	1.18 mm	3.2	34.91
30	600 μm	2.0	23.21
50	300 μm	1.8	20.91
100	150 μm	0.9	10.46
200	75 μm	0.4	4.65
Pan		0.12	3.49

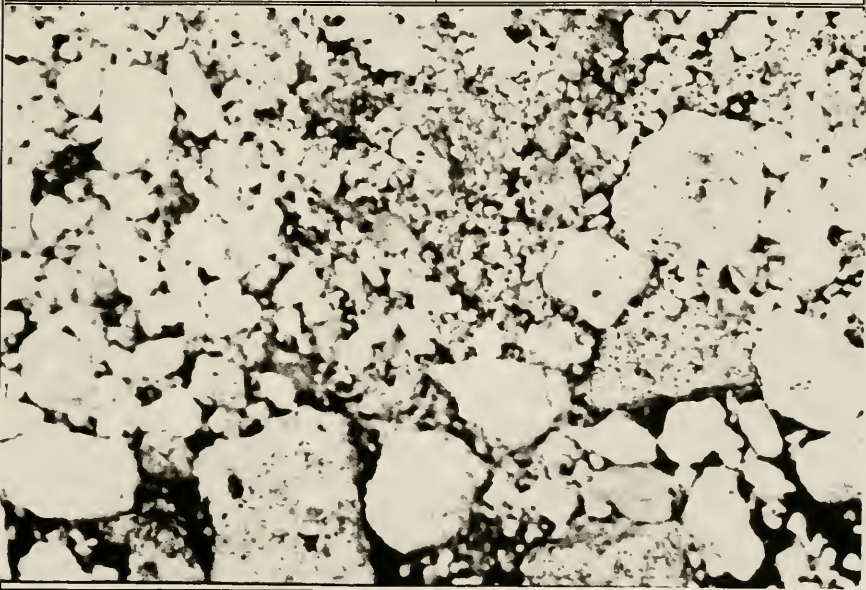
A black and white photomicrograph showing a dense collection of coarse fraction material. The particles are predominantly subround to subangular in shape, with varying sizes and textures. Some particles appear smooth and light-colored, while others are darker and more irregular. The overall distribution is heterogeneous, typical of a natural aggregate sample.

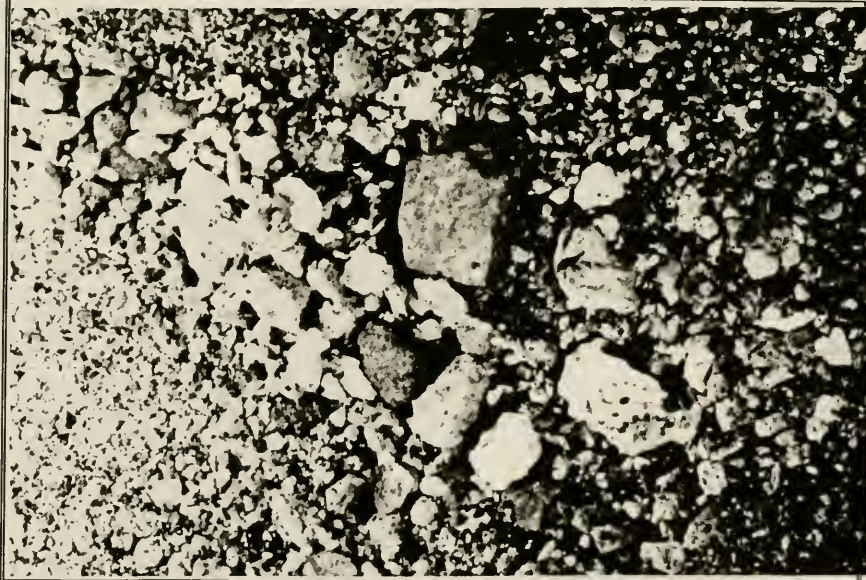
COARSE FRACTION EXAMINATION		SAMPLE #: 101	
Floor Name: Hun Nal			
Sample Location: MAS, top of platform, west side.			
Division: 6	Date: A.D. 250 - 420		Magnification: 10x
Shapes: Subround and subangular.			
Colors: Green, brown, rust, yellow, white, and tan.			
SIEVE ANALYSIS			
Sieve #	Size	Weight (grams)	% Retained
8	2.36 mm	0.44	55
16	1.18 mm	0.16	20
30	600 μ m	0.14	17.5
50	300 μ m	0.06	7.5
100	150 μ m	0	0
200	75 μ m	0	0
Pan		0	0

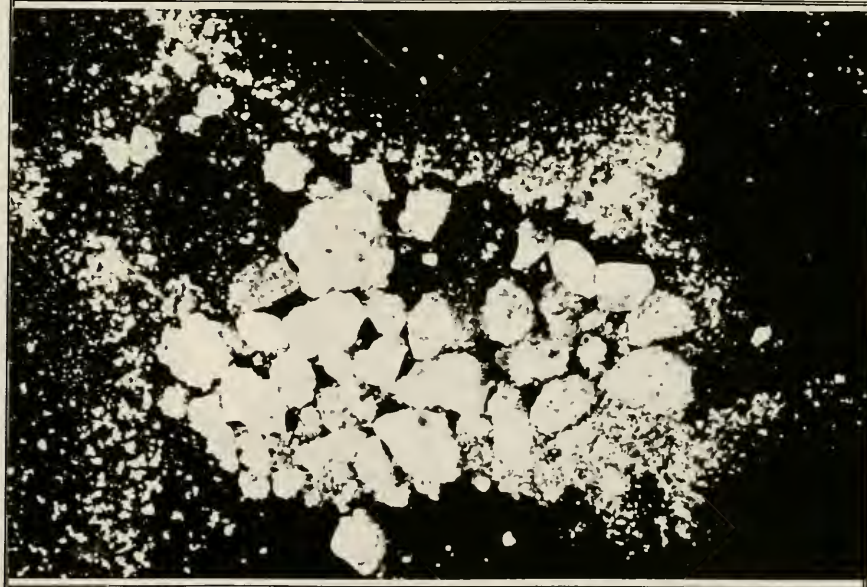
COARSE FRACTION EXAMINATION		SAMPLE #: 26733-1	
Floor Name: Piso Don Lorenzo			
Sample Location: Rosalila, abuts modified west steps of Azul.			
Division: 2	Date: A.D. 540 - 650	Magnification: 5x	
Shapes: Subround and subangular.			
Colors: Brown, red, white, green, gray, orange, and tan.			
SIEVE ANALYSIS			
Sieve #	Size	Weight (grams)	% Retained
8	2.36 mm	0.56	4.55
16	1.18 mm	0.28	22.73
30	600 μm	2.72	22.08
50	300 μm	3.12	25.32
100	150 μm	2.04	16.56
200	75 μm	0.88	7.14
Pan		0.2	1.62

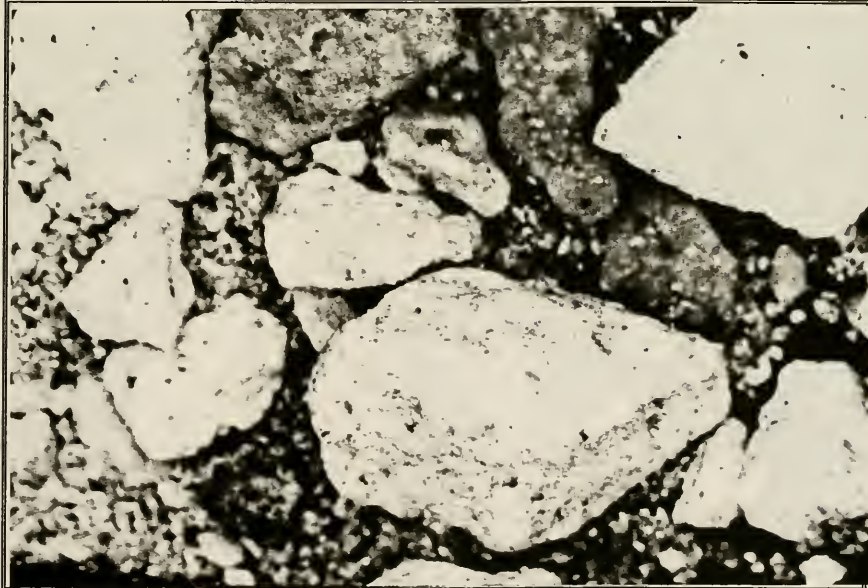
COARSE FRACTION EXAMINATION		SAMPLE #: 27304	
Floor Name: Piso Don Lupito			
Sample Location: Rosalila, runs under Azul platform.			
Division: 2	Date: A.D. 540 - 650	Magnification: 3.75x	
Shapes: Subangular and subround.			
Colors: Green, red-brown, brown, tan, and white.			
SIEVE ANALYSIS			
Sieve #	Size	Weight (grams)	% Retained
8	2.36 mm	1.18	62.11
16	1.18 mm	0.6	31.58
30	600 μm	0.08	4.21
50	300 μm	0.04	2.10
100	150 μm	0	0
200	75 μm	0	0
Pan		0	0
